SITE INSPECTION ML 47288

Date: June 1, 2006

Lease #: O,G & H, ML 47288

Lands Inspected: N½ Section 2, T5S, R20E, SLB&M, Uintah County

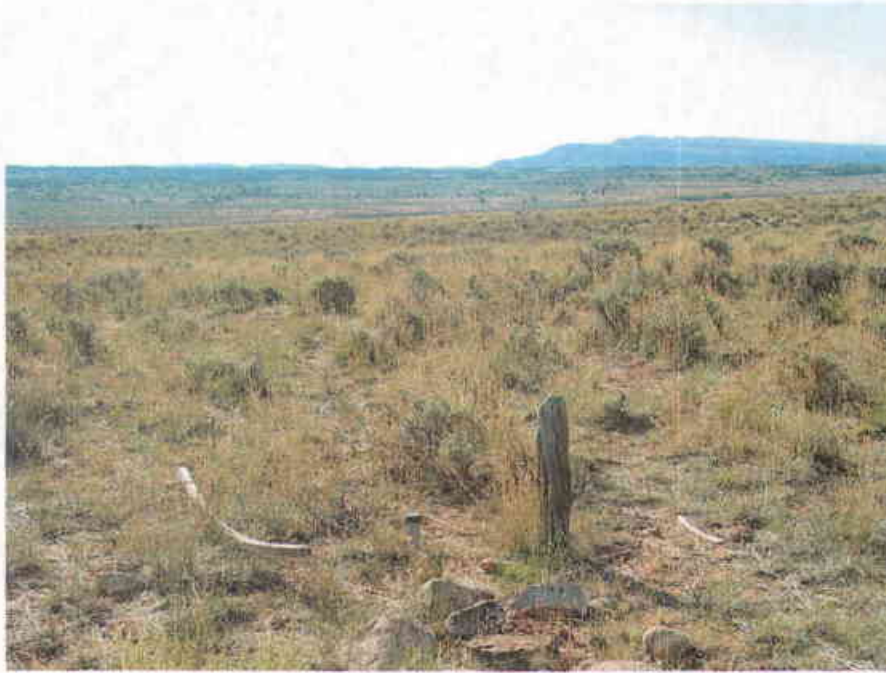
ML 47288, 6-1-06 Looking southeast from the northwest corner of Section 2. The section corner brass cap is just to the left of the wooden post.

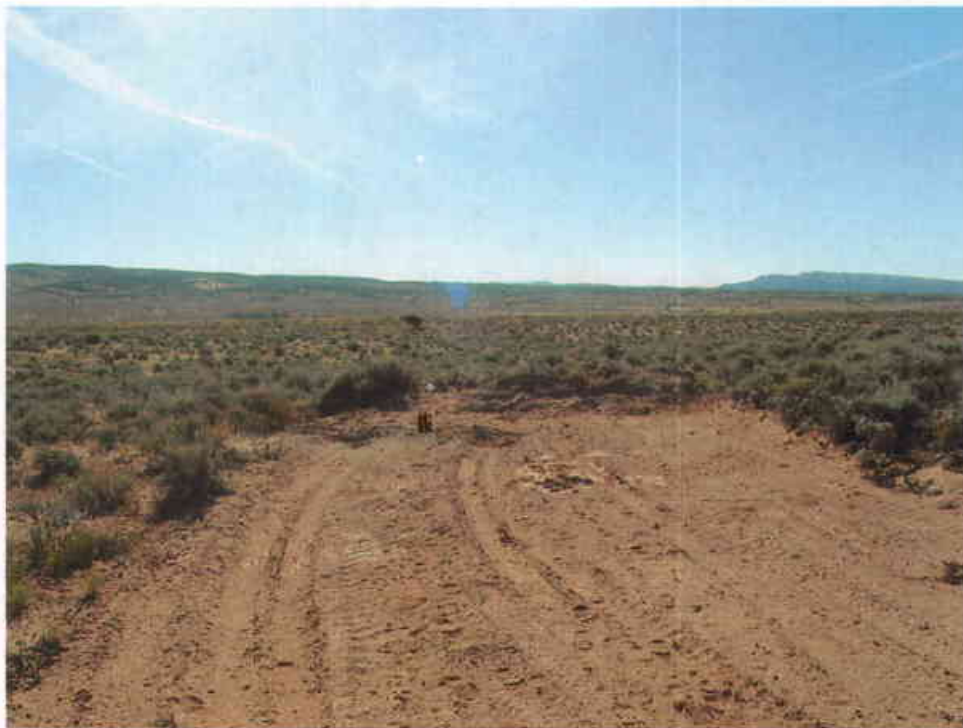
ML 47288, 6-1-06 Looking east onto a drill hole which is located in Section 3, just south and west of the northwest corner of Section 2. UTM coordinates are: N 4475009.82, E 614382.56.

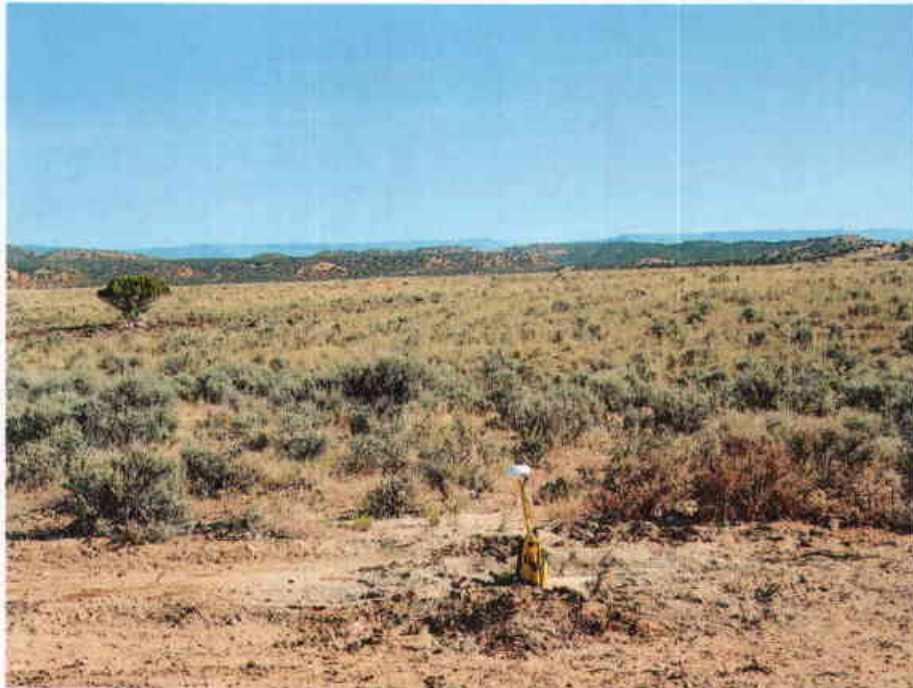
ML 47288, 6-1-30 Looking north from the drill hole depicted in the previous picture. Due north is toward the tree in the left of the picture. The northwest corner of Section 2 is shown on the right of this picture. This drill hole is clearly south and west of Section 2.

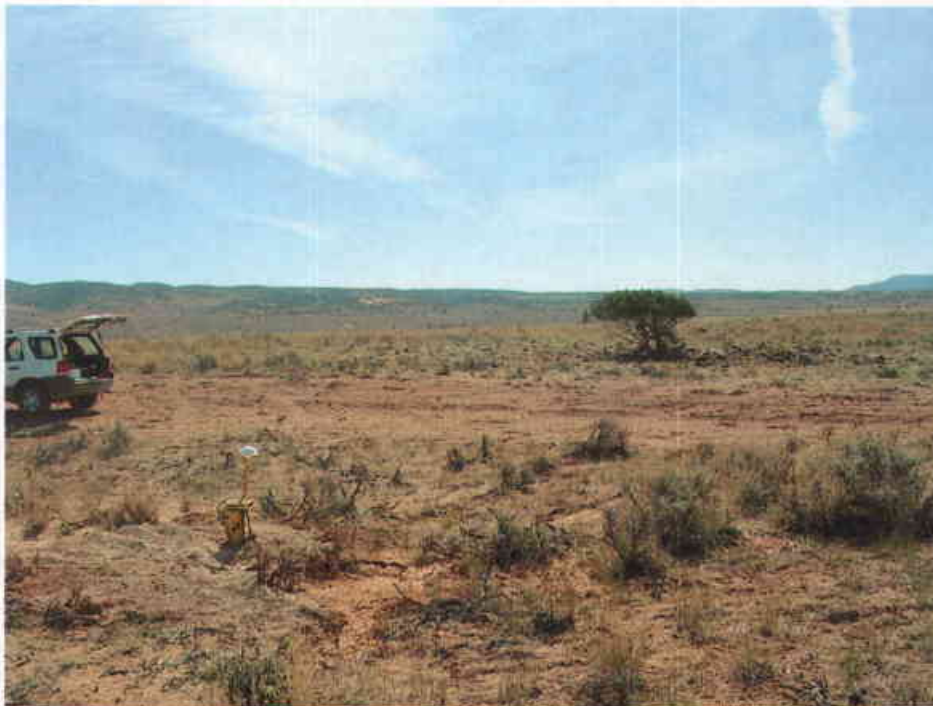
ML 47288, 6-1-06 Looking east to the northwest corner of Section 2 which is indicated by the post past and to the left of the tree. This drill hole is clearly west of Section 2. The UTM coordinates are: N 4475091.34, E 614339.39

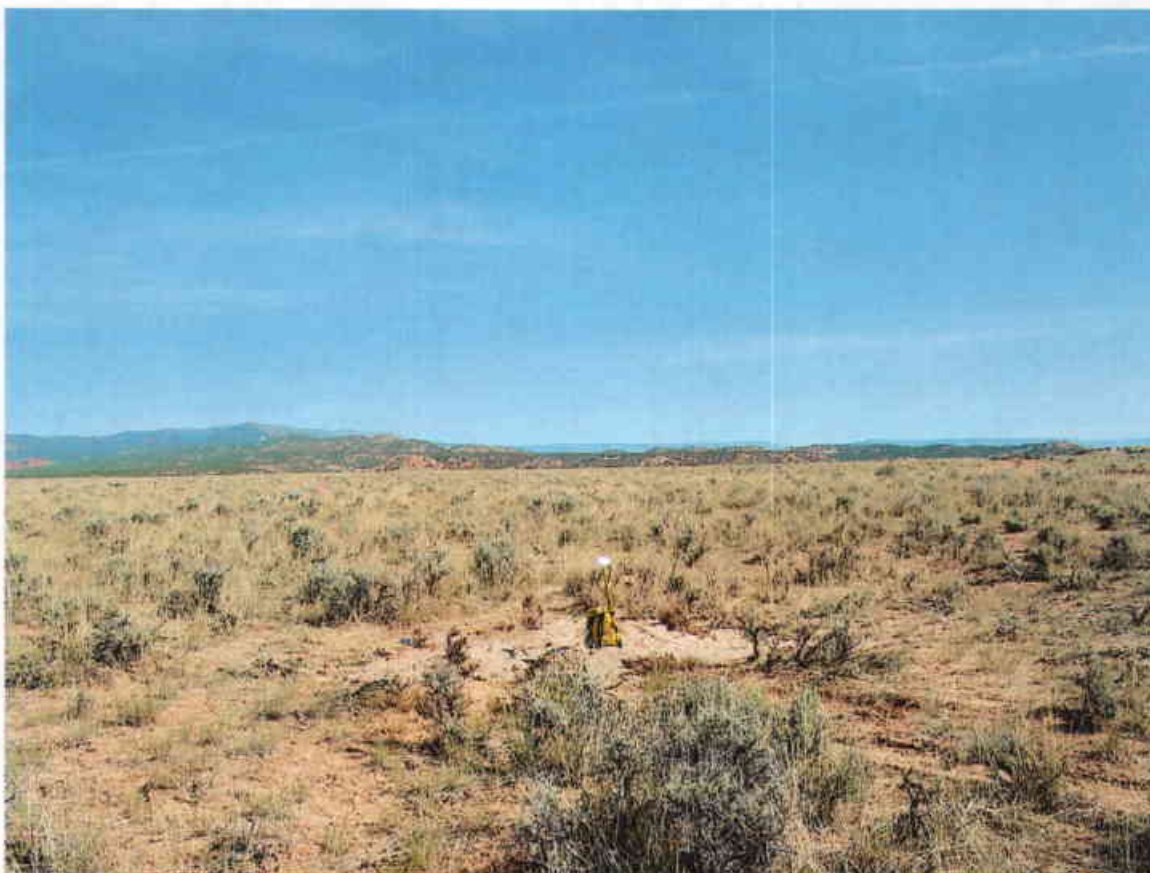
ML 47288, 6-1-06 Looking north from the drill hole in the previous picture. In the distance and to the left of this location is a wood lath, painted red, on which is written "Corner 288-7, 40* 25.133N and 109*39.100". It is believed that the survey marker was placed where the surveyor believed the northwest corner of Section 2 should be.
